# TECHNICAL BULLETIN 1.0

## *UNBONDED TENDON REPAIR SERIES*

### **REPAIR OF DAMAGE AT LATERALLY DIVERTED TENDONS**

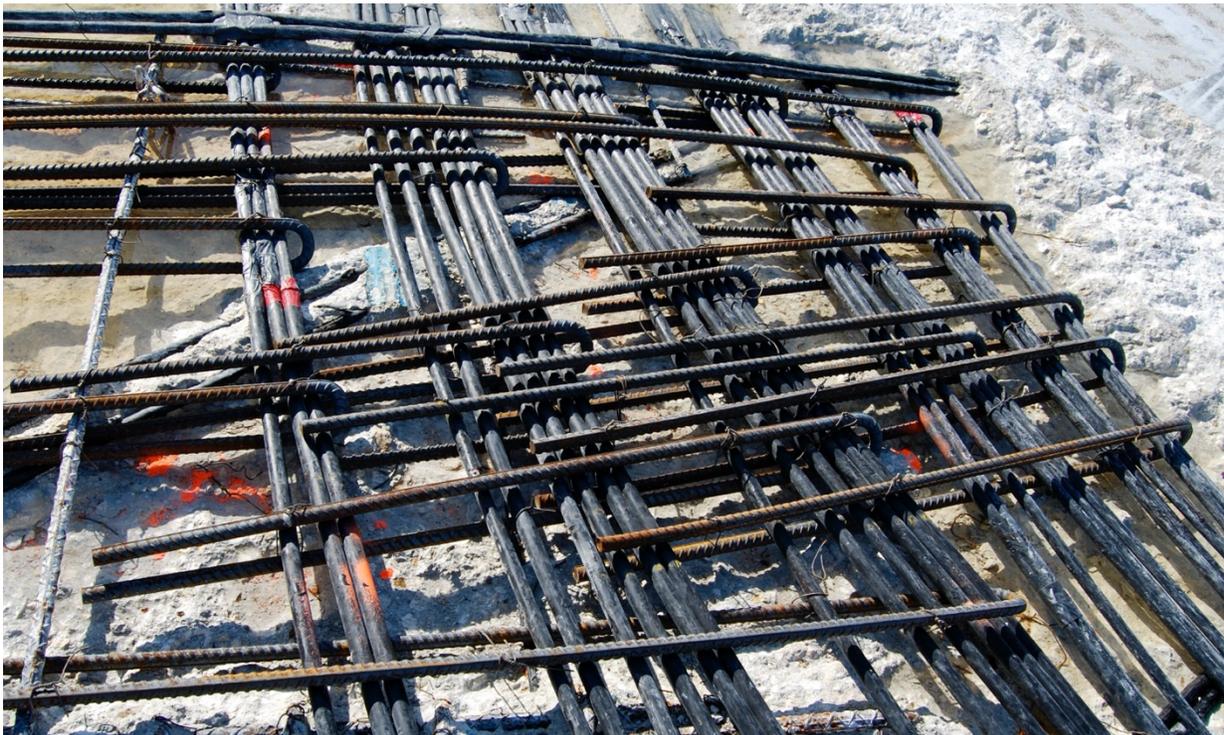
*Photo: Supplemental hairpin reinforcement added at banded tendon lateral sweep repair.*

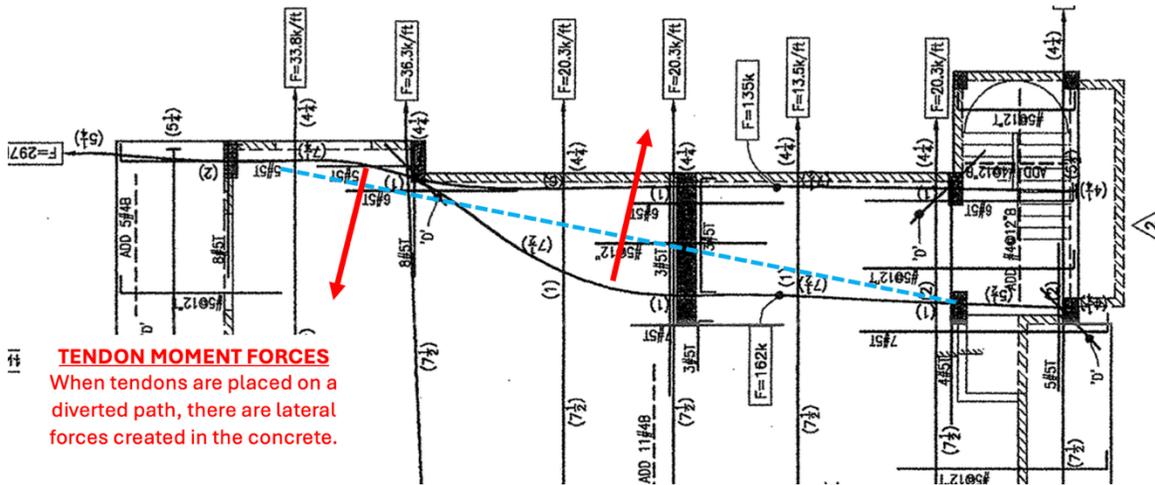
Image: Plan view sketch showing lateral tendon force in slab structure.

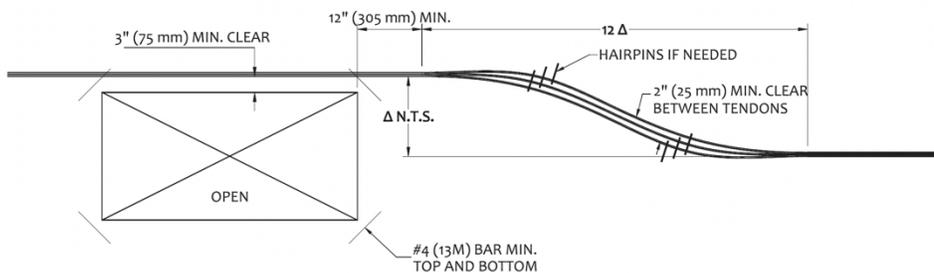
Fig. 4-6 — Typical detail of tendons deviating around an opening and tendon sweeps.

Image: The Post-Tensioning Institute recognizes the need for additional mild reinforcement in lateral sweeps.

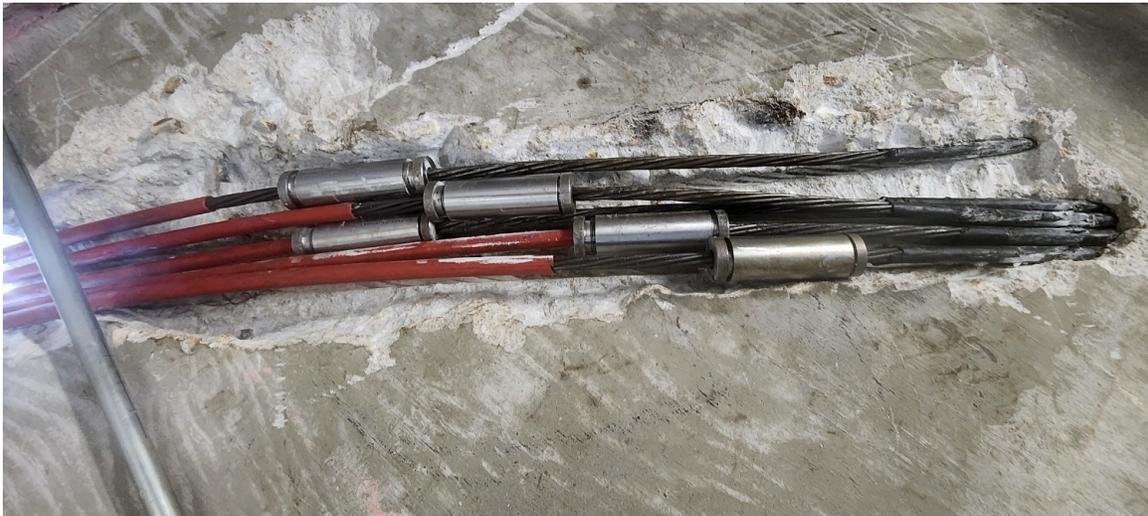
Photo: Installation of these splice couplers within the tendon sweep places an eccentric load on the hardware.

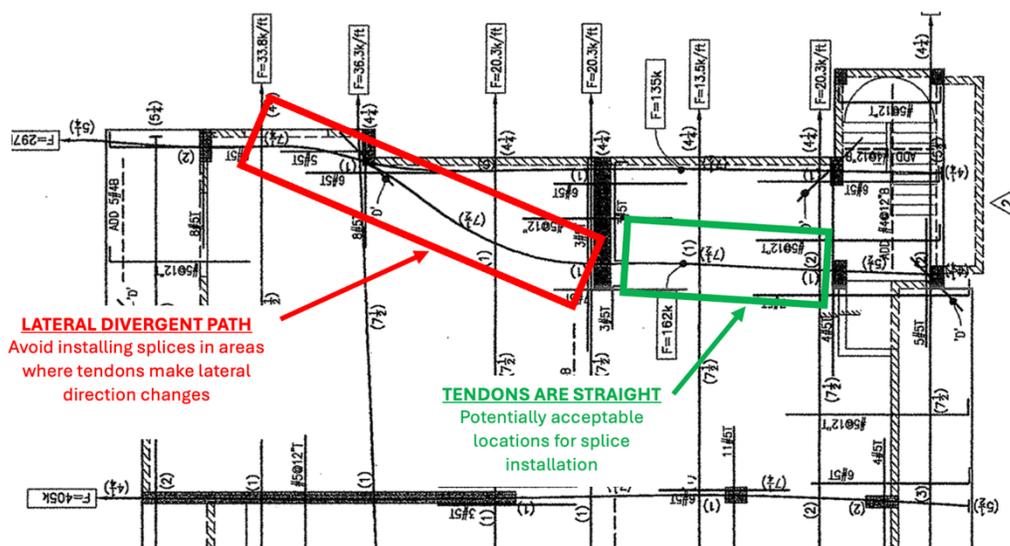
Image: Plan view sketch shows locations to avoid when installing splice couplers.
