TECHNICAL BULLETIN

Post Tensioned Structural Repairs

THE IMPORTANCE OF CONCRETE PREP GEOMETRY FOR POST-TENSION REPAIR

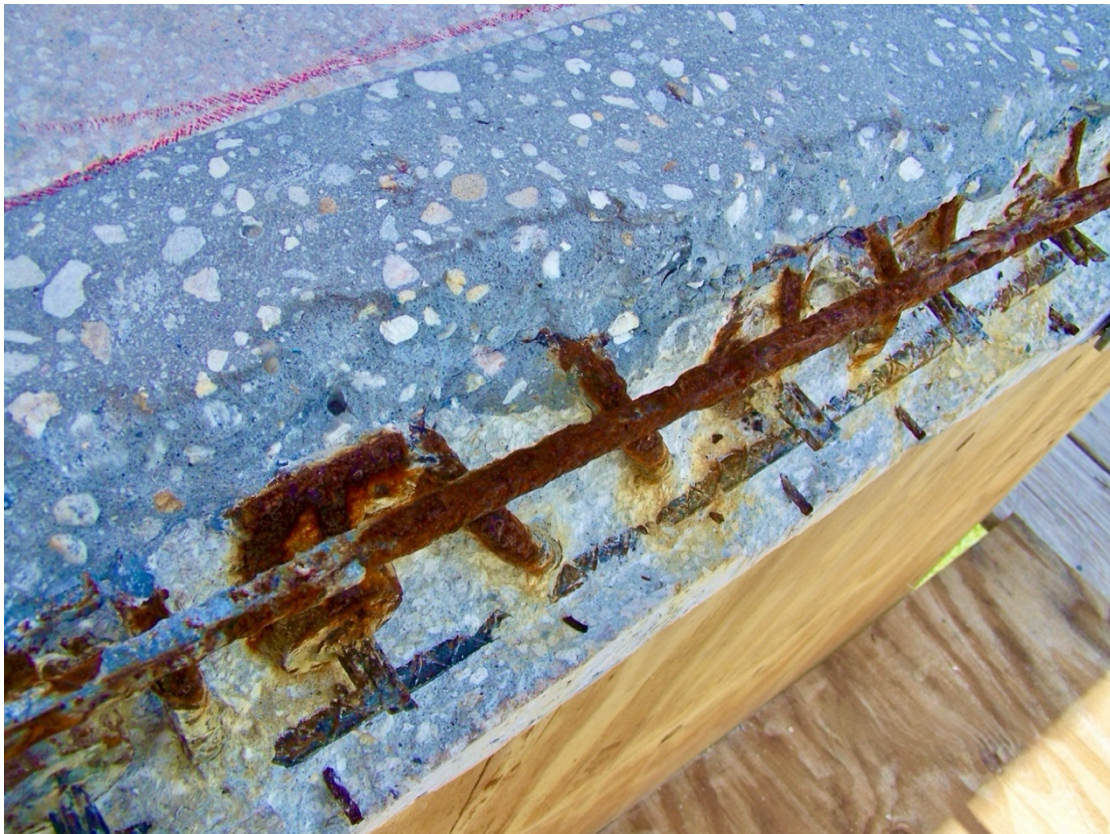
The persistent deterioration of previously repaired post-tensioned concrete, particularly around tendon anchors, is a developing phenomenon that some in the post-tensioning and structural repair communities have not yet fully recognized. The underlying cause of failure of these prior repairs can often be attributed to the use of incorrect repair demolition geometry that leads to the development of a highly active corrosion cell, which results in accelerated corrosion of the embedded mild steel reinforcement and the post-tensioning. This is an important issue because the potential loss of post-tensioning can compromise the integrity of a structure.

Photo: Old patching material is clearly visible, exposing advanced corrosion of embedded steel.

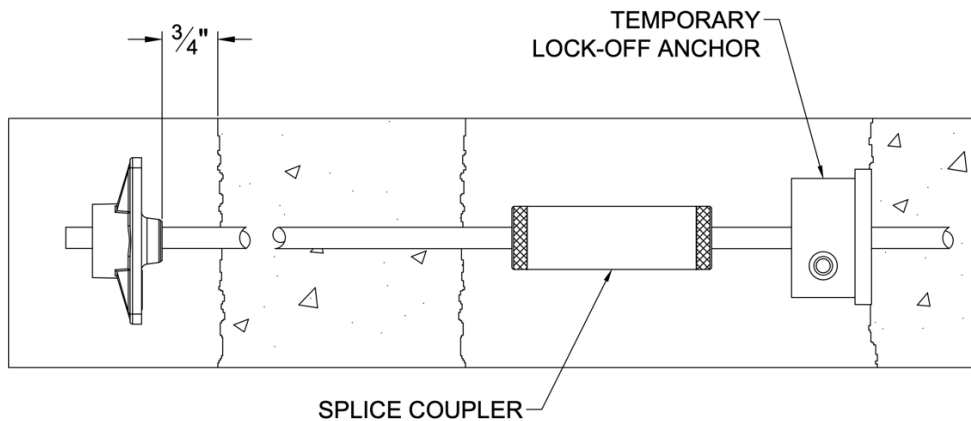
Image: Note that the ICRI required excavation extends into the high-stress zone behind the anchor.

When performing concrete structural repairs, the ICRI *“Guide for Surface Preparation for the Repair of Deteriorated Concrete Resulting from Reinforcing Steel Corrosion”* recommends a “minimum of 0.75 in. (19 mm) clearance between exposed reinforcing steel and surrounding concrete or 0.25 in. (6 mm) larger than the coarse aggregate in the repair material, whichever is greater.”
