TECHNICAL BULLETIN

Post Tensioned Structural Repairs

JUNE 2025

MONOSTRAND POST-TENSIONED STRESSING ANCHOR POCKET DAMAGE & REPAIR

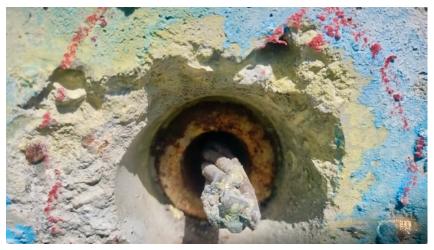
This condition is usually identified after the pocket grout has been removed and the wedges are found to be either loose or missing. While this could be the result of a wedge seating failure at the fixed end anchor during tensioning, that's often not the case, because the cables remain fully engaged with the opposing fixed end terminal anchorage. Were the failure to have occurred at the fixed end, the repair would typically require either the replacement of the entire tendon length, or the installation of a splice coupler in order to add the length of strand needed to stress the tendon. If the cable remains anchored at the fixed end anchor, then there exists the possibility of tensioning at the stressing anchor location, but this requires a specialized repair protocol and equipment. Additionally, the condition of the cable tail is critical in determining if restressing of the existing cable will be possible. If the cable tail is too short, or too badly corroded, there will not be enough usable strand available to permit retensioning.

Image 3: Cable found with missing wedges after the grout was removed.

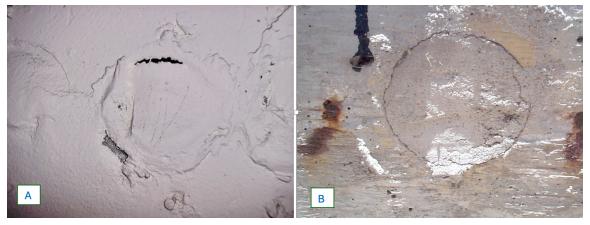
Other common problems that are found during structural remediation are usually the result of improper mixing or placement of the cementitious grout used to fill the anchor pockets. These include excessive cracking at the bond line between the grout and the concrete substrate, and voids in the pocket grout. Shrinkage cracking is often the result of retempering of the grout mixture during installation, which results in excessively high water-cement ratios. Additionally, the surface of the stressing pocket concrete can be contaminated with grease from the strand or other contaminants, which will inhibit proper bonding of the grout to the concrete pocket surface. Problems of this nature can be very detrimental to the useful life of the post-tensioning because it may permit water to ingress directly into the tendon anchor and result in accelerated corrosion of the steel elements. This issue can be particularly detrimental when the stressing anchors are subjected to prolonged direct water exposure. Anchors located below grade level can be exposed to rainwater, landscaping irrigation, or even the water table. Additionally, any anchors located in structures that retain water, such as planters, water tanks, or swimming pools, may be subjected to increased hydrostatic water conditions and pressurized water infiltration. In these situations, the installation of a waterproof membrane at the surface can be critical in protecting the anchor pockets from water infiltration.

Image 4A: Void located at the top of the stressing anchor pocket. 4B: Drying shrinkage cracks in grout.

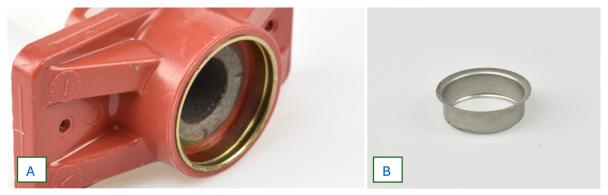
Many encapsulated anchors use a metal burn ring that is incorporated into the anchor. This ring serves two purposes; it protects the anchor encapsulation plastic from the heat of an oxygen acetylene torch used to cut the cable tails to length, and it provides a rigid interface to engage with the grease cap used to seal the anchor encapsulation. When the metal ring has sustained heat damage, it disrupts the integrity of the tendon encapsulation. The repair of this condition has been addressed using replacement metal rings, but this repair is becoming increasingly difficult because of the lack of availability of the metal rings. That's because manufacturers are reluctant to provide only the burn ring due to liability concerns associated with their use retroactively.

Image 5A: Encapsulated anchor with burn ring installed. 5B: Replacement burn ring.

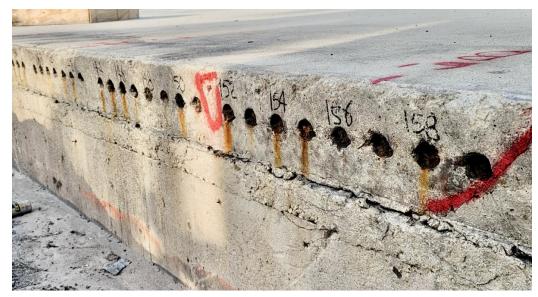
This is more of an issue caused by the location of the stressing anchors relative to the surface of the concrete. Stressing anchor pockets can vary in depth, but their design should provide adequate coverage for the face of the anchor. There are conditions where anchors are placed too close to the concrete surface and coverage is minimal. This condition is primarily observed with non-encapsulated anchors, which increases the corrosion potential of the unprotected anchor, wedges, and strand.

Image 6: Anchors placed too close to the surface and lacking adequate stressing anchor pocket coverage.

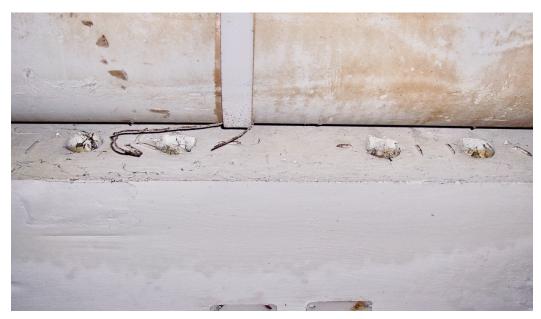
This is a condition that is often found at interior tendon terminations, usually at an expansion joint. It's assumed that the contractor believed that it was unnecessary to fill the anchor pockets with grout because the expansion joint would protect the stressing anchors from water exposure. However, expansion joints are eventually likely to fail, which then places the post-tensioning at an increased risk of damage due to corrosion resulting from exposure to water.

Image 7: Unfilled anchor pockets located at interior expansion joint.

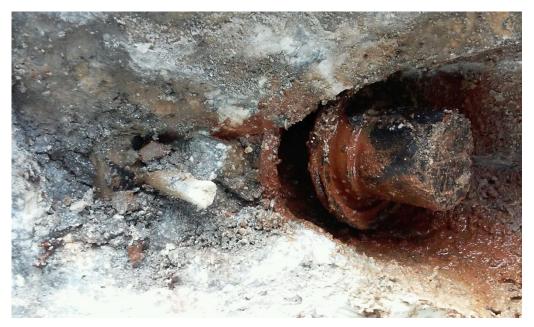
Water infiltration into the tendon strand and sheathing can be the single most significant cause of cable failure that is associated with the stressing anchor pocket condition. While it is possible for water to enter the tendon through cracks in the concrete structure, irregularities in the stressing anchor pocket grout and encapsulation can provide avenues for water to enter directly into the tendon. This is particularly a concern when the anchors are located at or below grade, or at other locations where the anchors can be exposed to prolonged hydrostatic water pressure such as planters, pool walls, and gutters. It should also be recognized that certain types of architectural elements such as stucco and EFIS details, located on top of the anchor pockets, can retain water if delaminated. In these circumstances, there is an increased importance of inspecting the anchor pockets to determine if they were finished correctly. At the very least, the anchor locations should be visually inspected for evidence of drying shrinkage cracks or voids in the pocket grout.

Image 8: Water leaking from anchor after pocket grout removed.

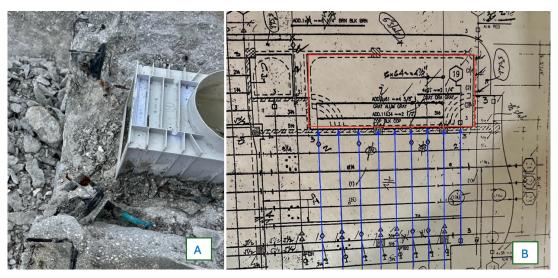
Image 9A: Exposed anchors at pool skimmer. Image 9B: Plan showing stressing anchors located in pool wall.

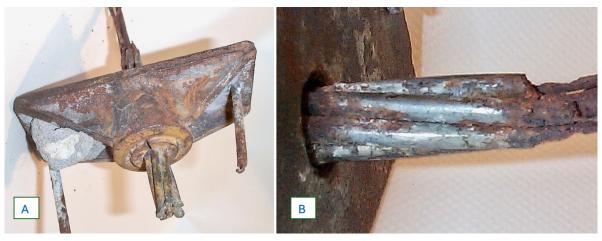
However, it can be more complex and difficult to assess the condition of encapsulated anchor systems. The primary reason is that the tendon components are isolated from direct exposure to the surrounding concrete by means of the plastic strand and anchor encapsulation, which insulates the steel components from electrochemical corrosion potential. This limits the visual condition assessment to obvious signs of damage, such as displaced strand or wedges, or water exfiltrating from the exposed anchor. Finally, a word of caution regarding the broader interpretation of tendon conditions based on an inspection of the anchor pocket. It is recognized that there may be an interest in determining whether a tendon has been compromised by corrosion based exclusively on a visual inspection of the exposed steel anchor face and strand tail. However, experience has demonstrated that it can be difficult to reach a meaningful conclusion unless there are other factors that serve to reinforce this determination. These should include recognized deficiencies in the anchor pocket grout, evidence of water infiltration into the tendon, or damage to the mild steel reinforcement and concrete structure surrounding the terminal anchor, as well as evidence of structural distress (deflection, bending, punching shear, etc.), which would be an indication of the significant loss of post-tensioning in a localized portion of the structure.

Image 10a: This extracted anchor exhibits minimal corrosion of the strand tail, anchor, & wedges. 10B. Yet the portion of strand under tension had failed due to significant corrosion.

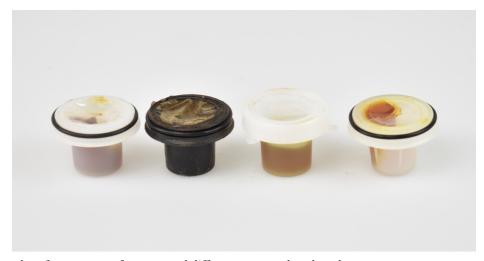
As the remediation of existing stressing anchor pockets is becoming an increasingly common part of many post-tensioned structural restoration projects, there is often little consideration given to whether the new available grease cap is compatible with the existing anchor burn ring. It's worthy to note that while many grease caps may appear identical, there is a high probability that there will be dimensional differences between the existing anchor cap and the available replacement. Experience has shown that while these differences may be slight, the fact remains that it may not fit as well as the original cap. Depending on the significance of these differences, the design professional may consider the replacement of the rubber O-ring with a sealant to help ensure a better seal.

Image 11: Examples of grease caps from several different encapsulated anchor systems.

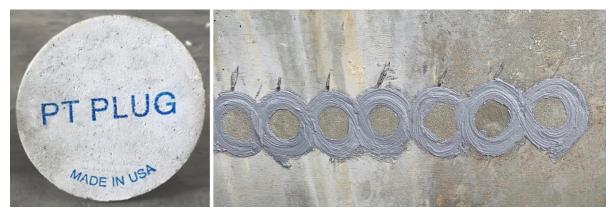
Image 13: The Precast Post Tension Plug before and after installation. (www.posttensionplugs.com)

The Post Tension Plug is an anchor pocket filler that is intended to help overcome problems associated with the installation of field mixed grout used to fill stressing anchor pockets. It's a precast plug made of 8,000 psi, non-shrink, non-metallic grout that is bonded to the anchor pocket with an epoxy adhesive. It is designed to fit the stressing pocket after it has been abraded using the Post Tension Plug Reaming Tool and ensures 1" of coverage after the grease cap has been properly seated.
